# **Addendum #1**

### **Site Testing Results and Scope Quantities**

June 03, 2020

RE: HAZMAT SURVEY REPORT FOR  
Adolfo Camarillo High School  
4660 Mission Oaks Blvd  
Camarillo, California 93012

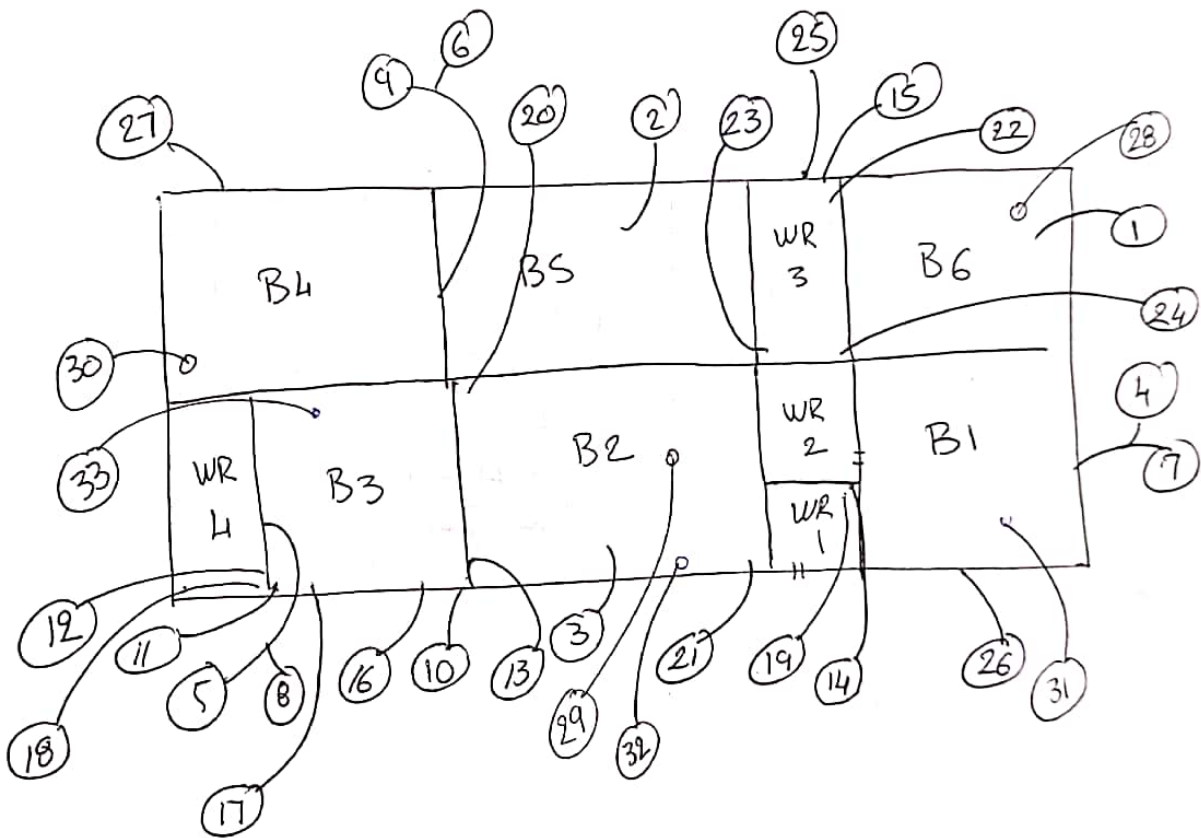
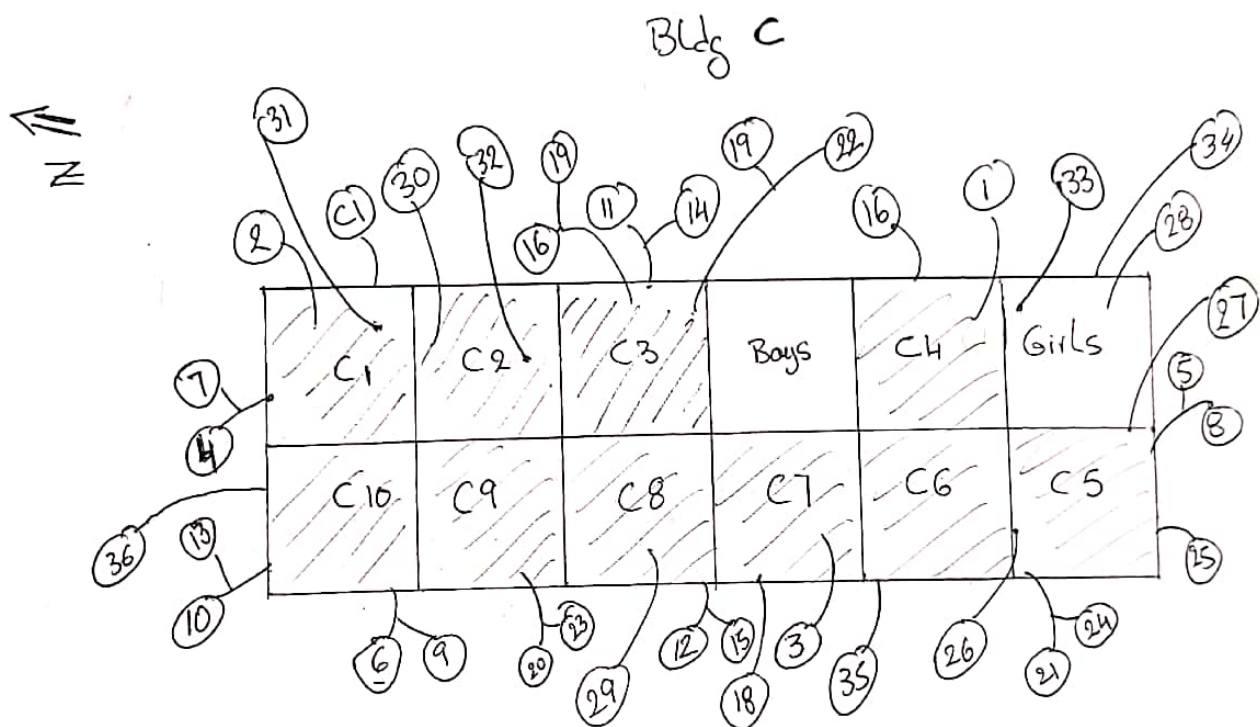
B Bldg

No suspect Material was observed in the ceiling space

/// Black fabric with RFT

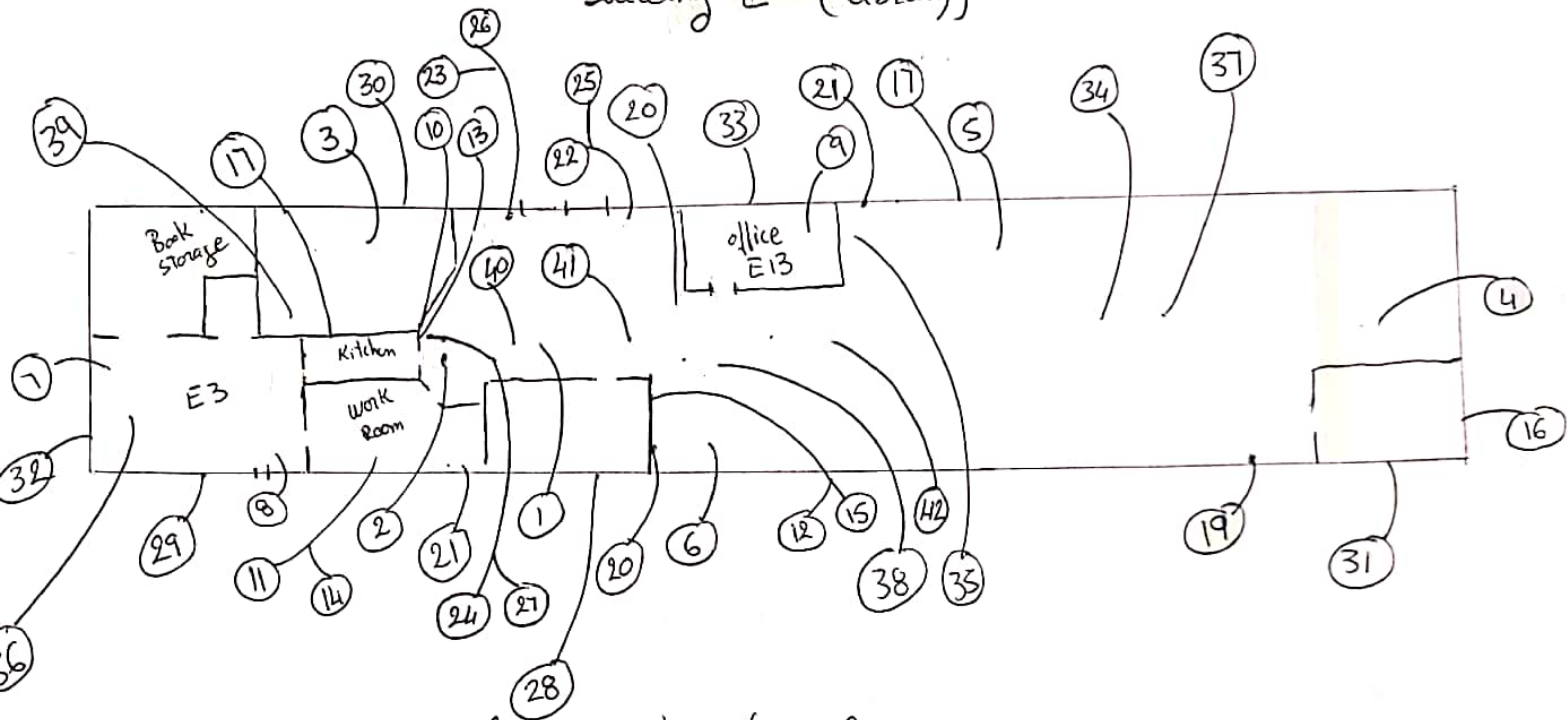
# Building E (Library)

No Suspect Material was observed in the Ceiling Space.

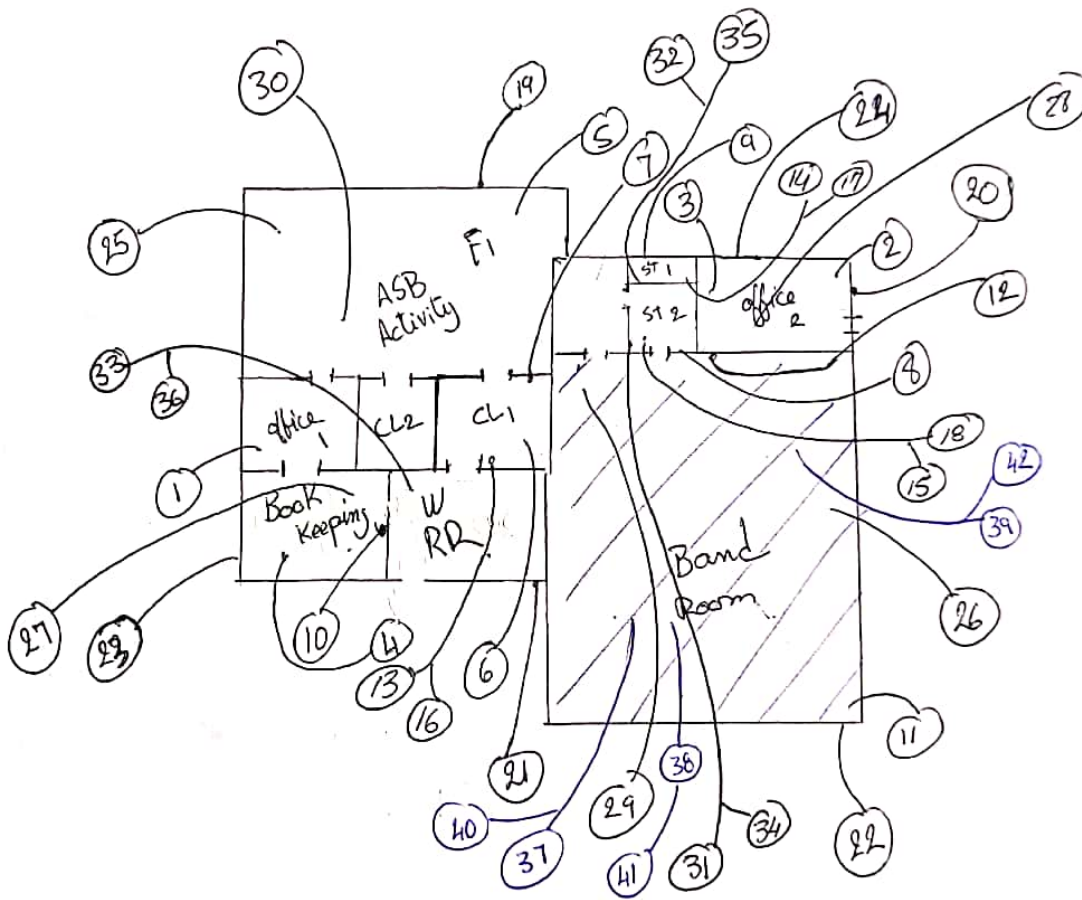
Bldg F

/// DW Ceiling  
in Band Room  
(only DW Ceiling in Bldg)

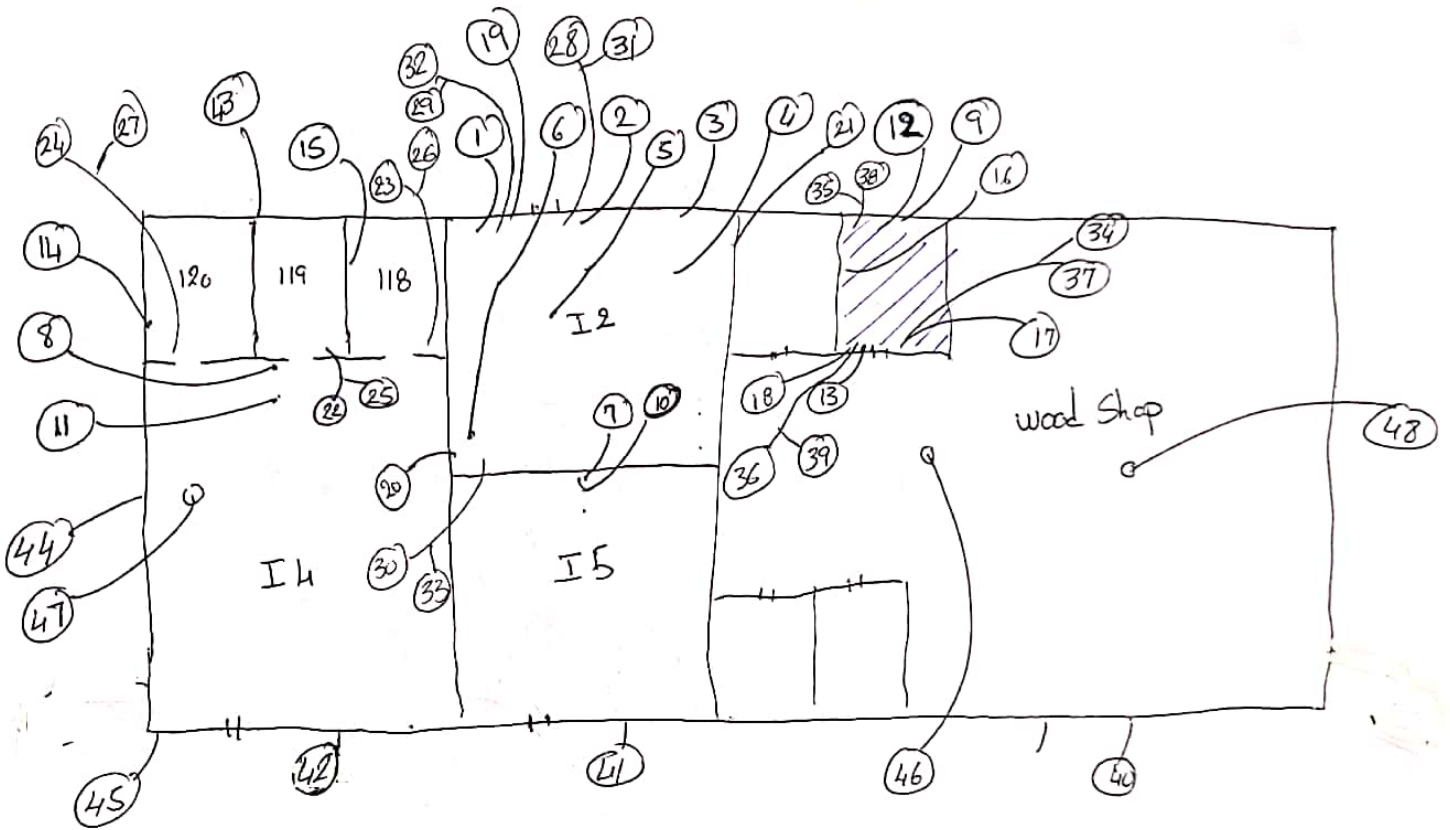
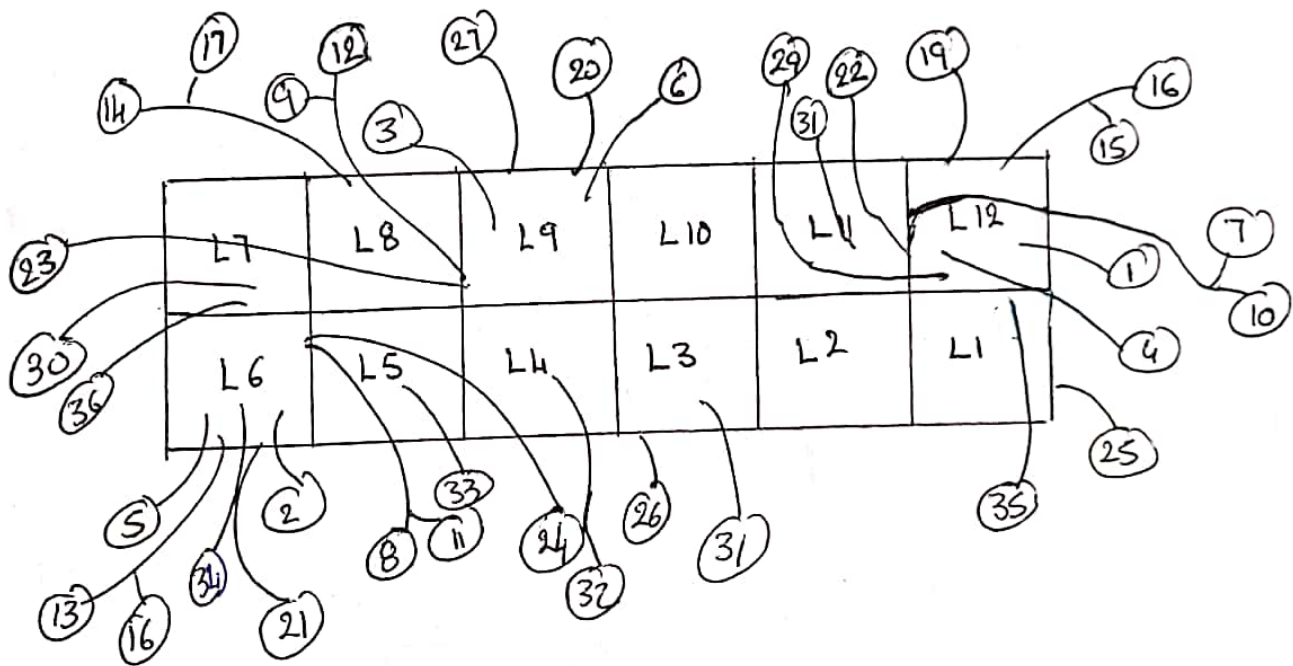
# Bldg I (woodshop)

111 9'x9" RFT

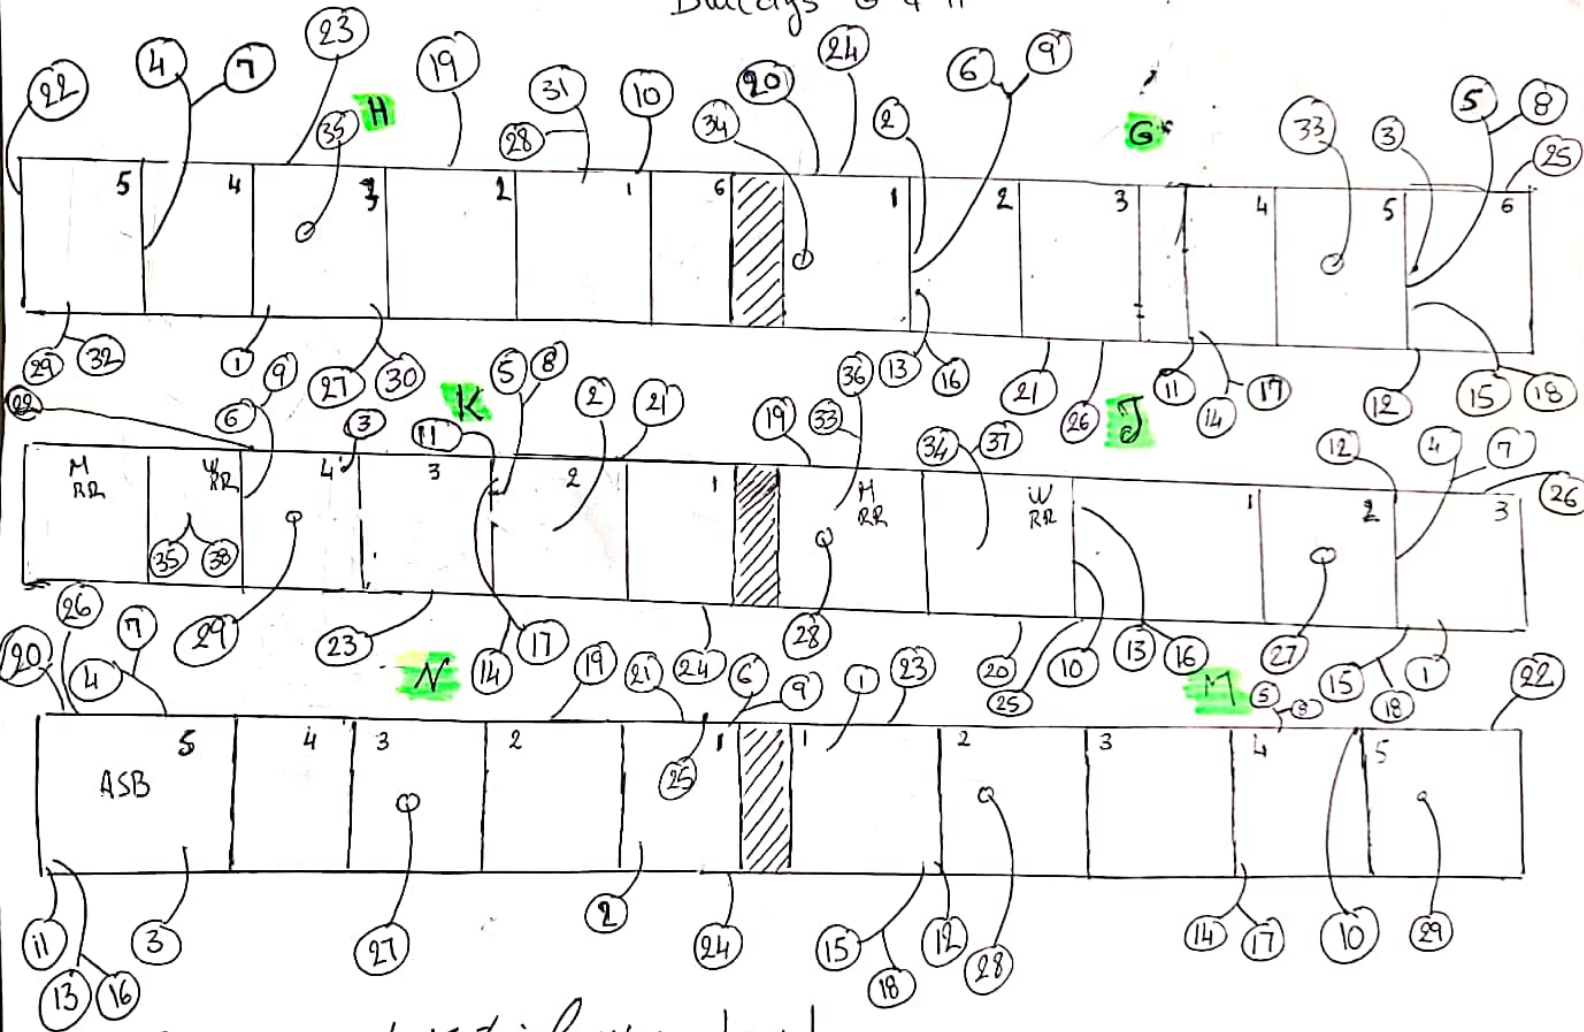
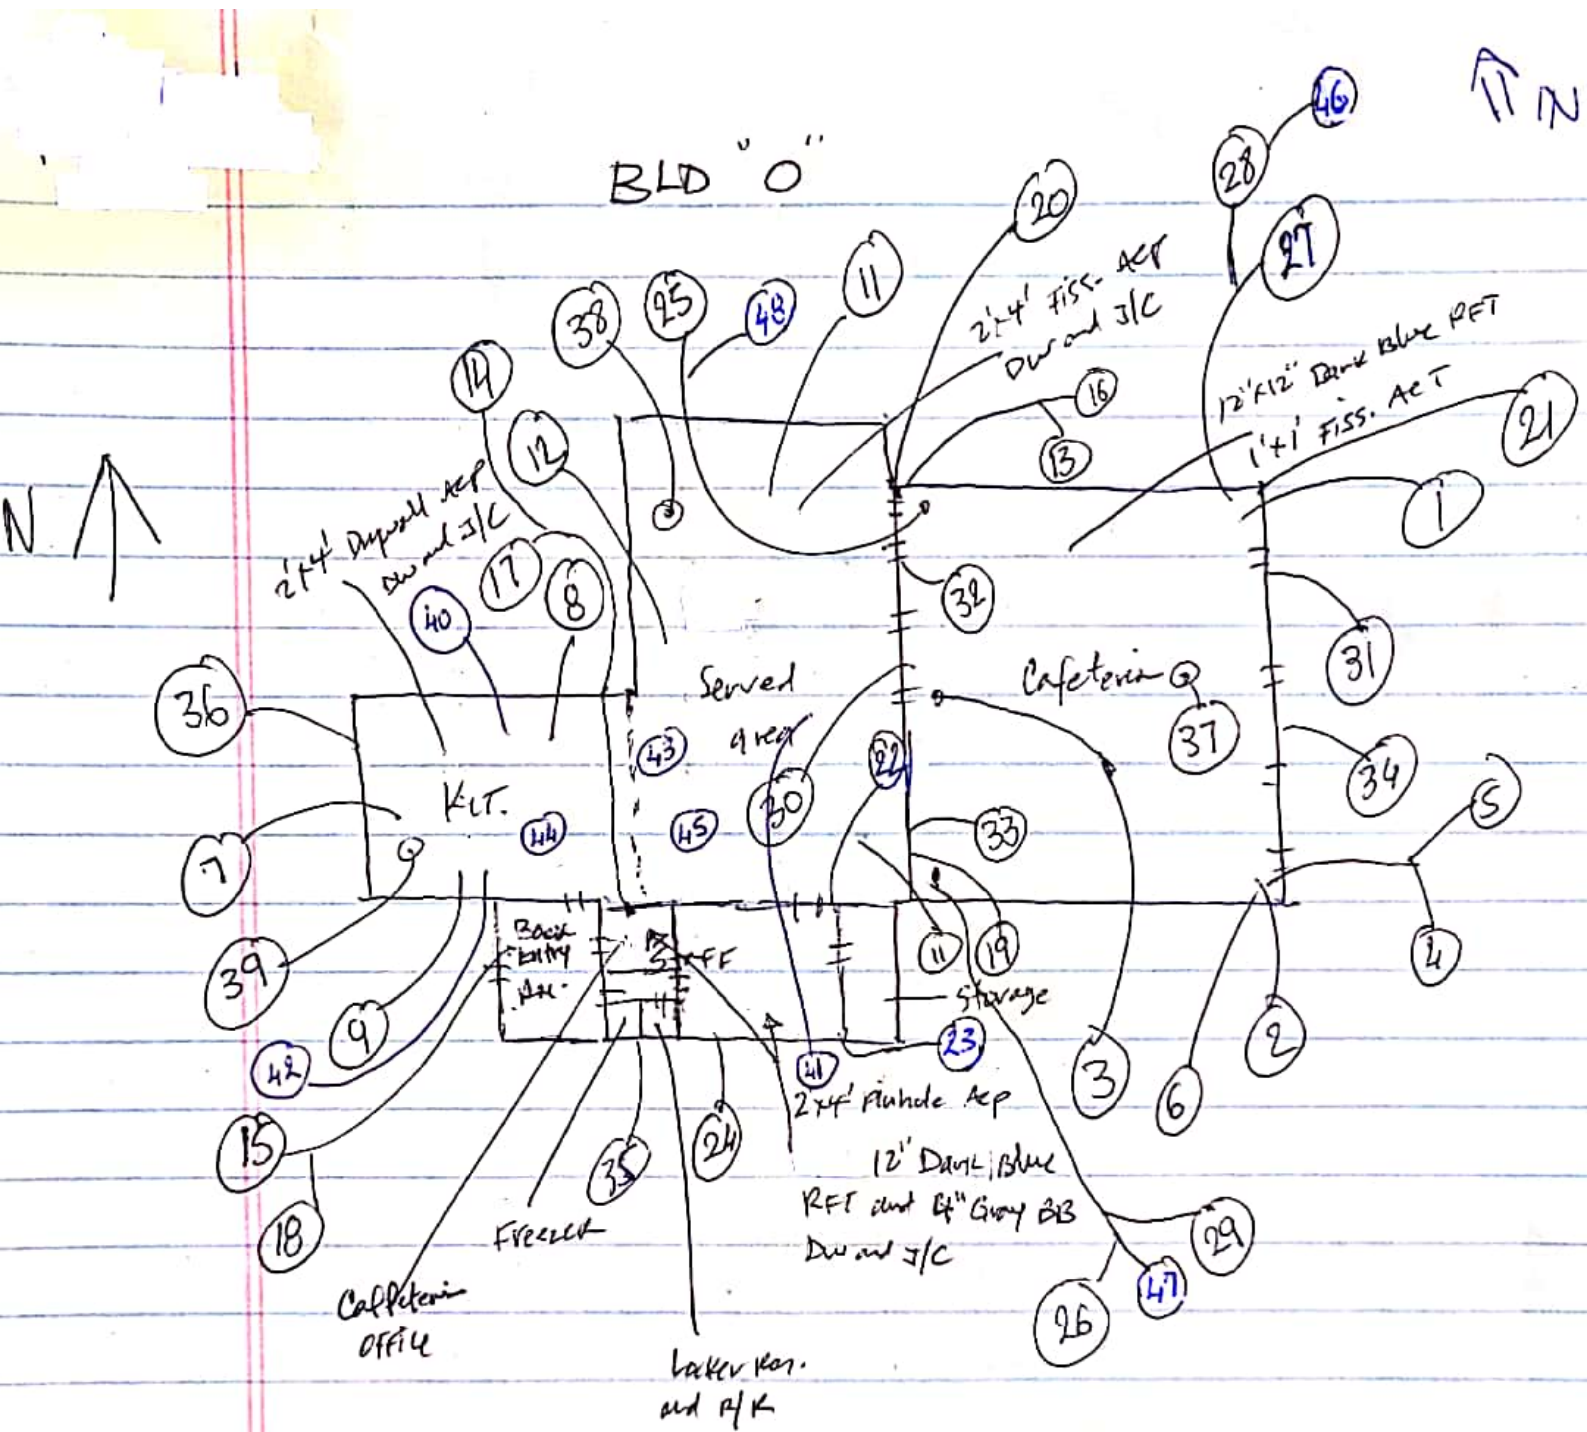
# Buildings G & H

{ No Suspect Material was observed  
in the Ceiling Space.

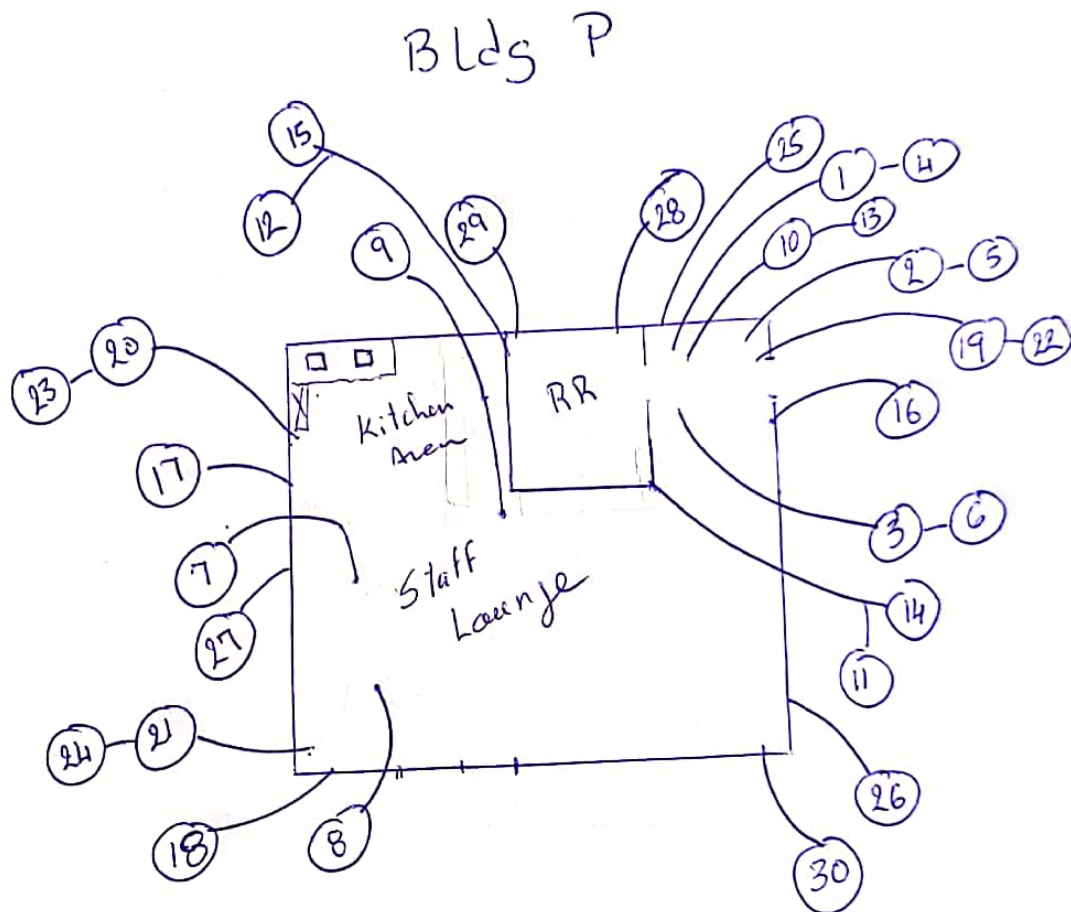
DW ceiling.
