Site Testing Results and Scope Quantities

**Asbestos Survey for
Channel Island High School
1400 Raiders Way
Oxnard, California 93033**

TC Project No. 103919

Date:
June 25, 2020

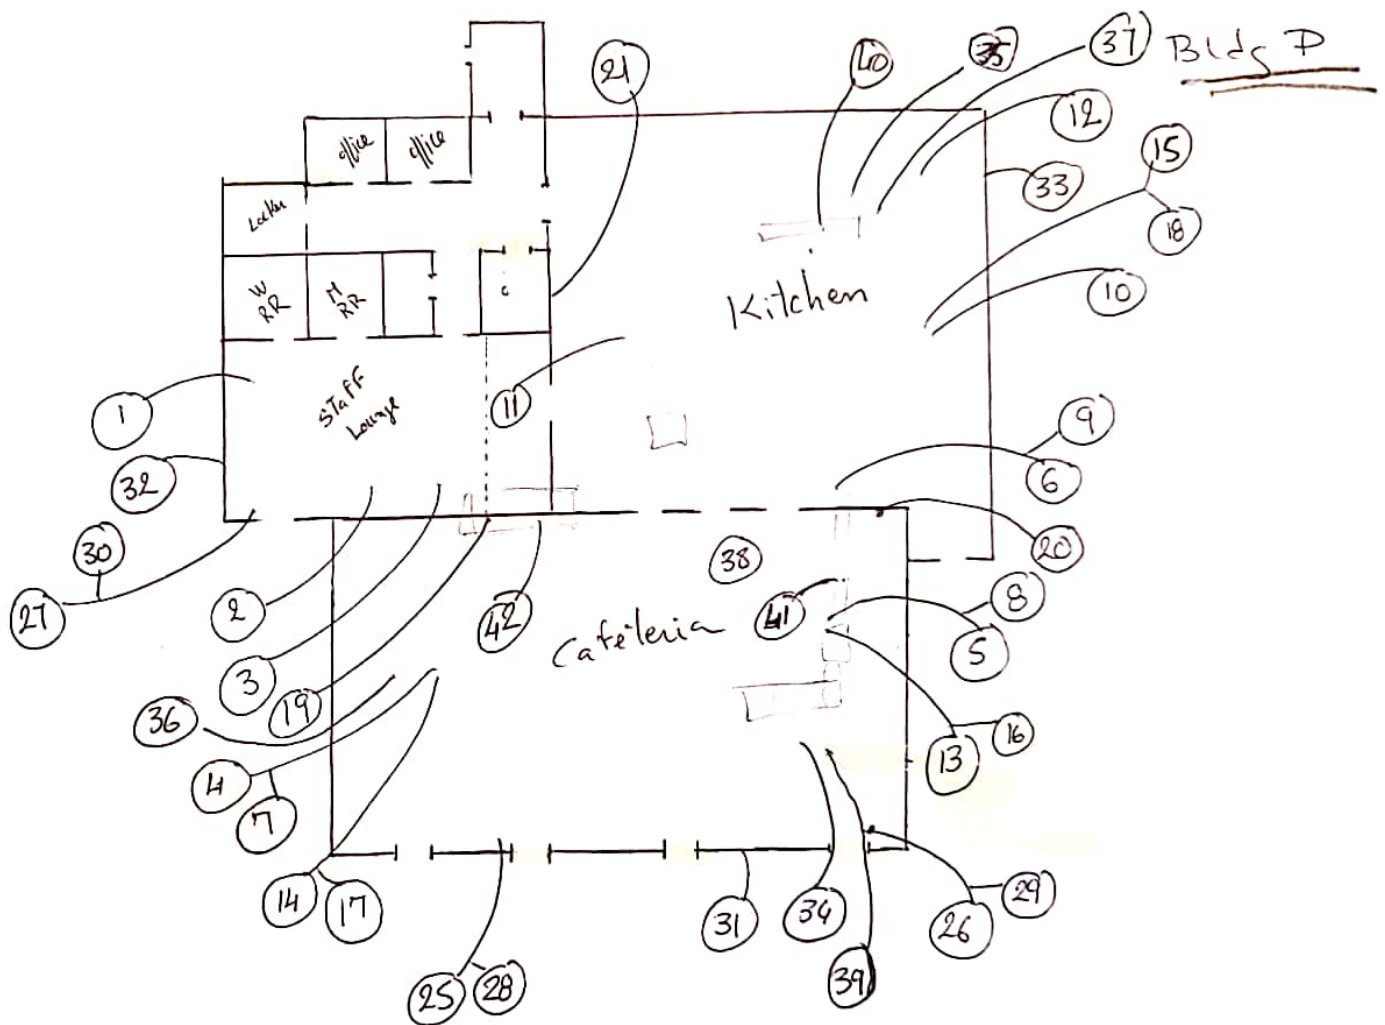
only one Transite pipe was observed on the roof
