**Asbestos Survey for
Adolfo Camarillo High School
4660 Mission Oaks Blvd
Camarillo, California 93012**

TC Project No. 103913

Date:
May 29, 2020

ASBESTOS SURVEY REPORT
ADOLFO CAMARILLO HIGH SCHOOL
4660 MISSION OAKS BLVD
CAMARILLO, CALIFORNIA

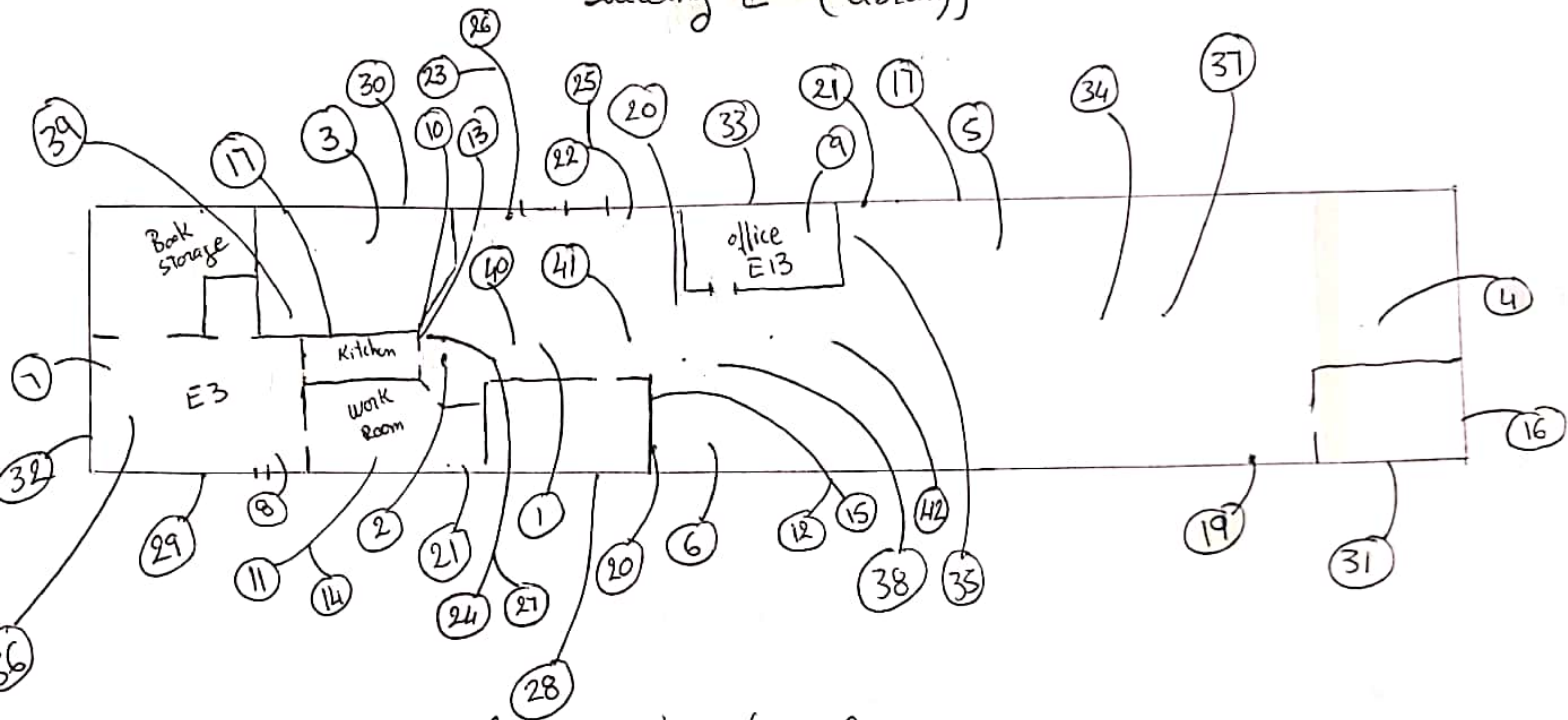
Building E (Library)

No Suspect Material was observed in the Ceiling Space.

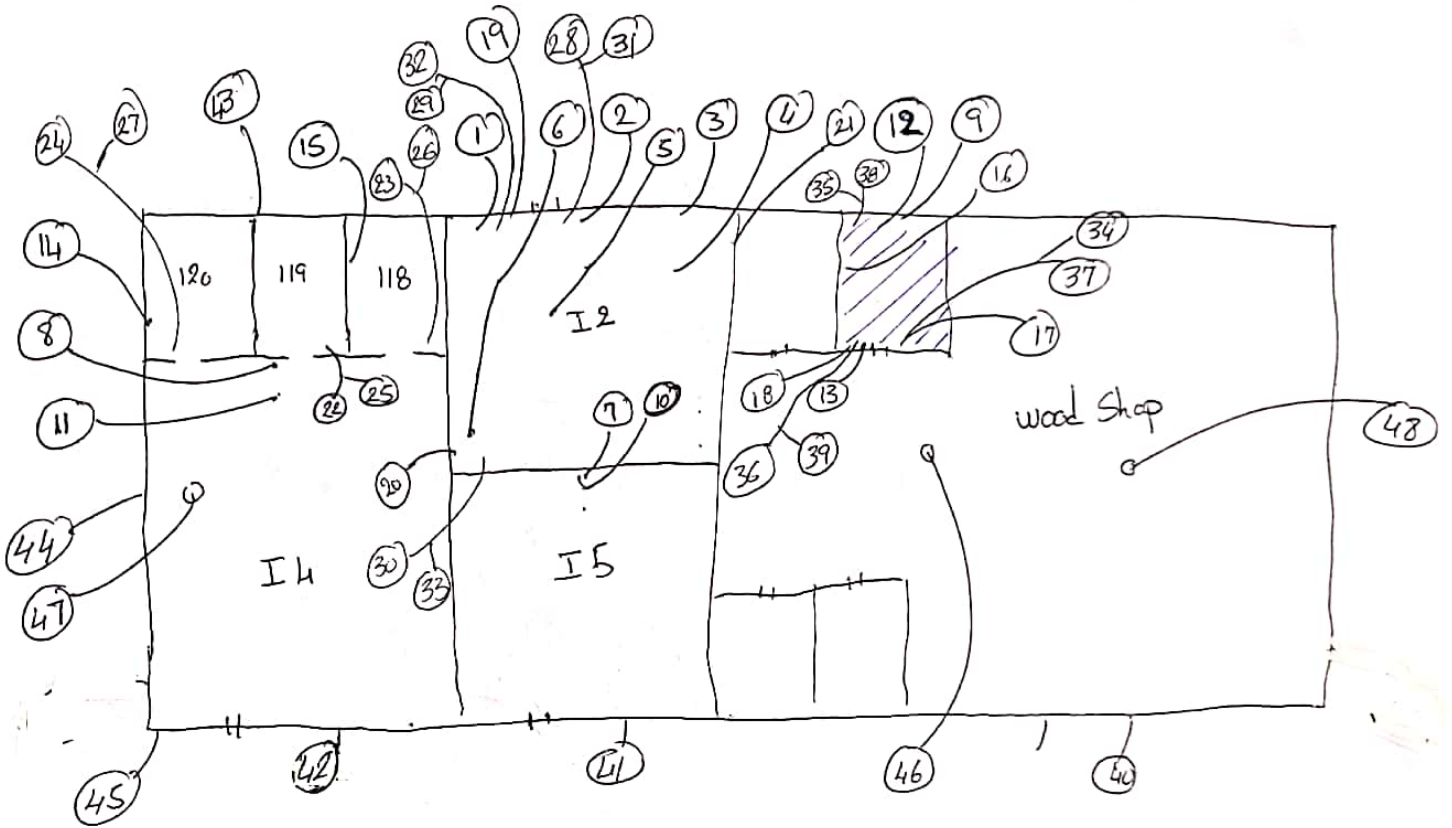
Bldg I (woodshop)

1/1 9x9" RFT

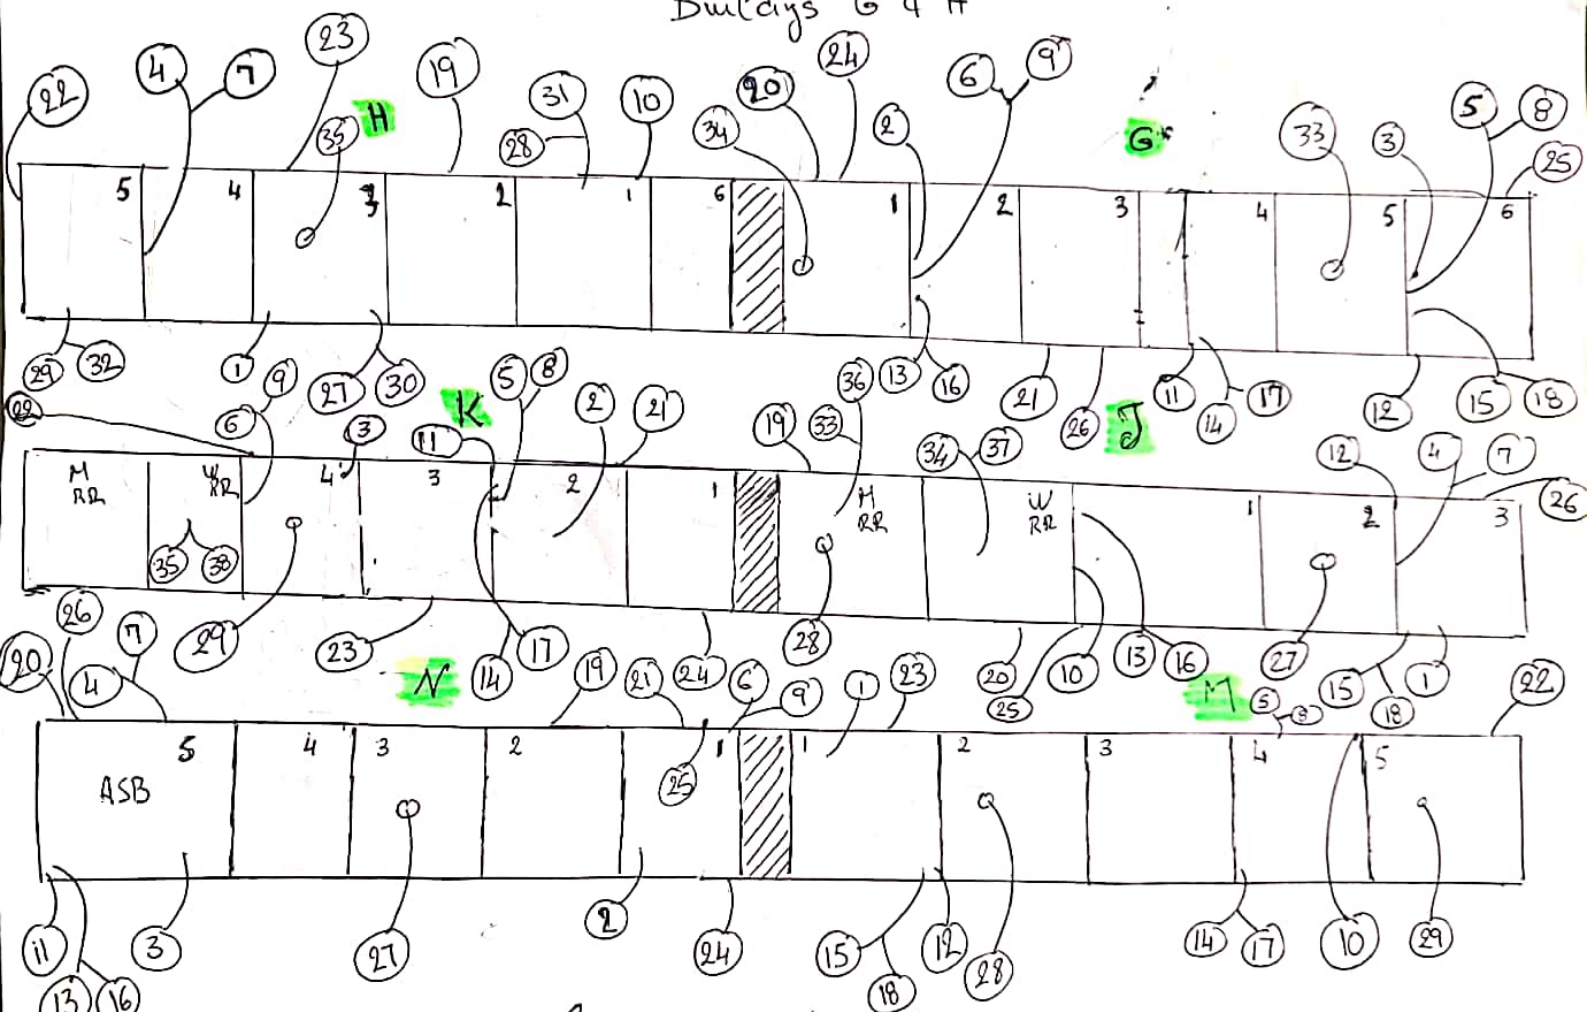
Buildings G & H

{ No suspect Material was observed
in the ceiling space.

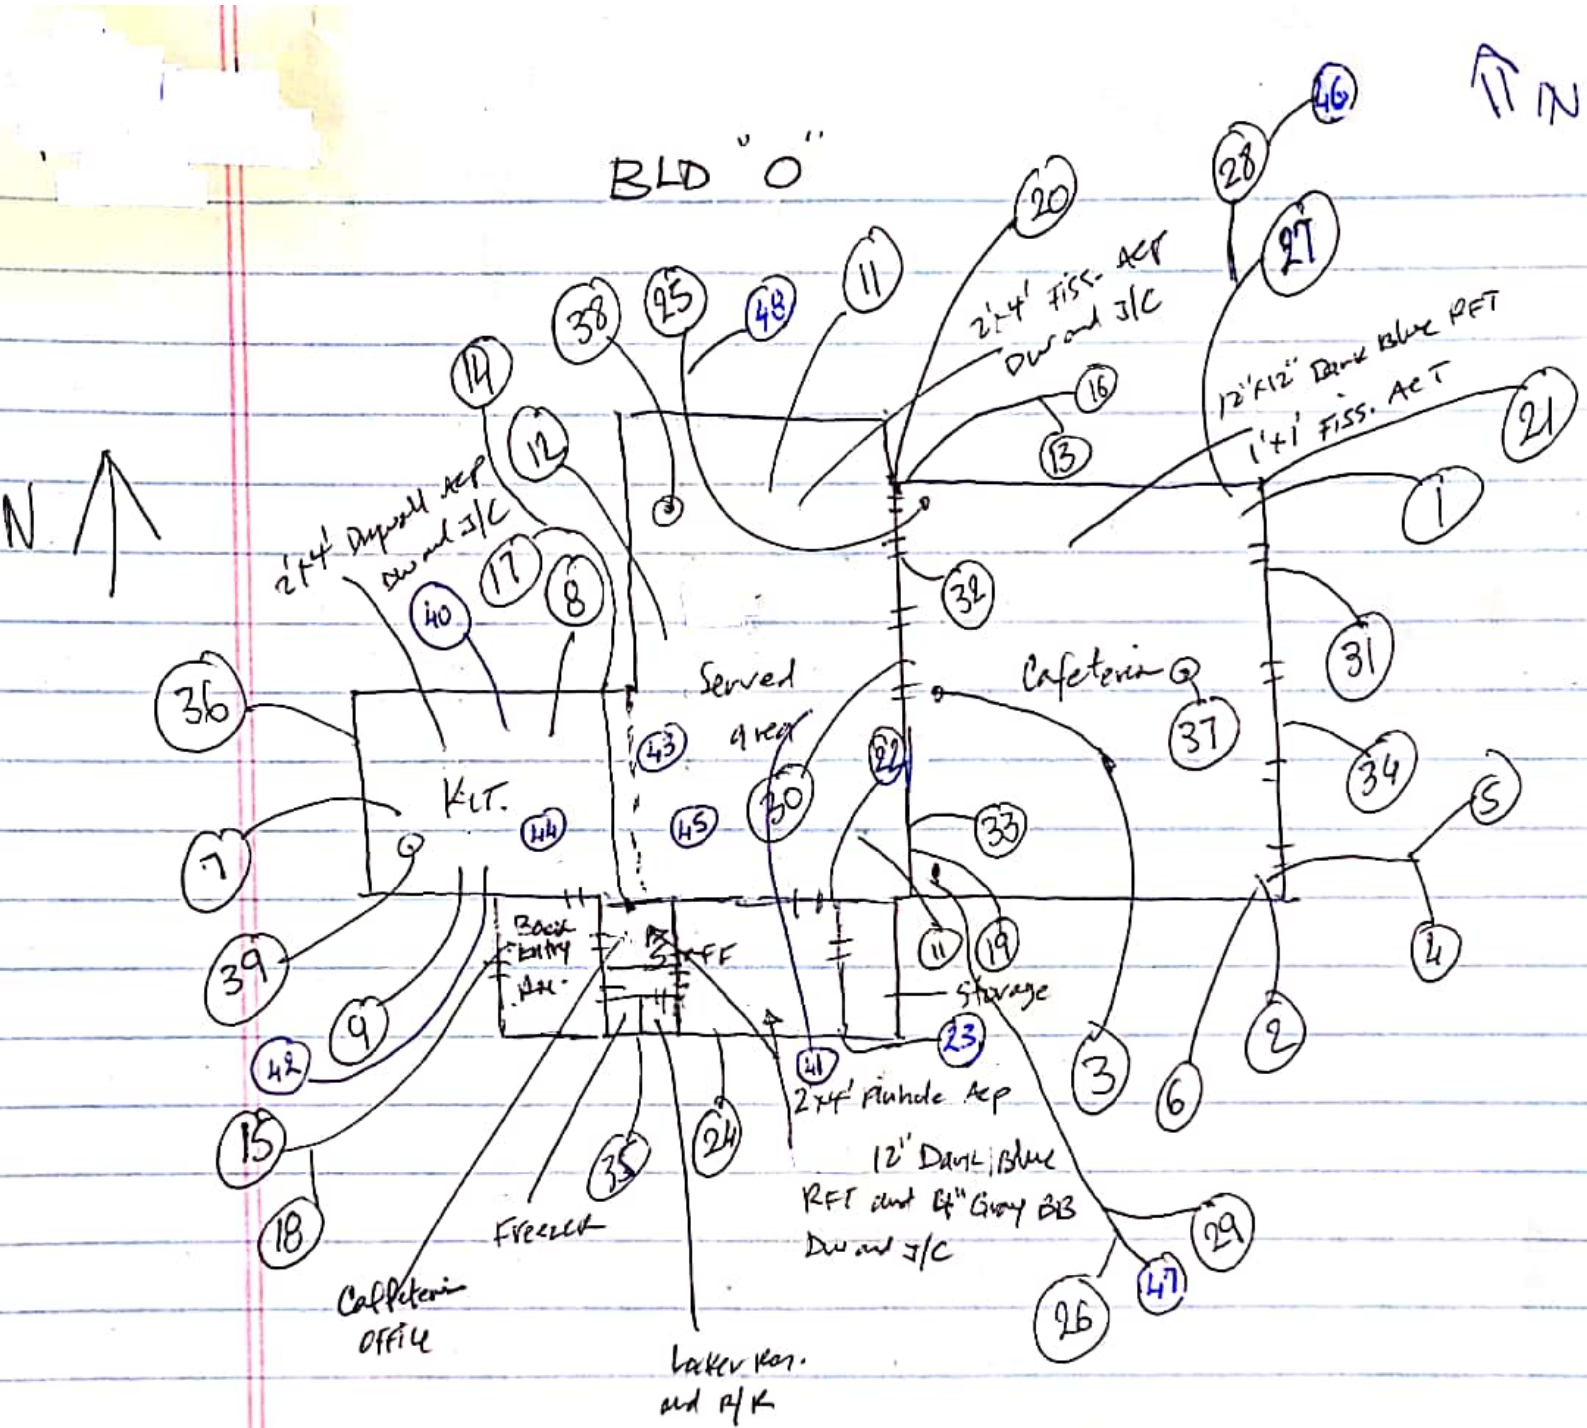
BLD "0"

DW ceiling.

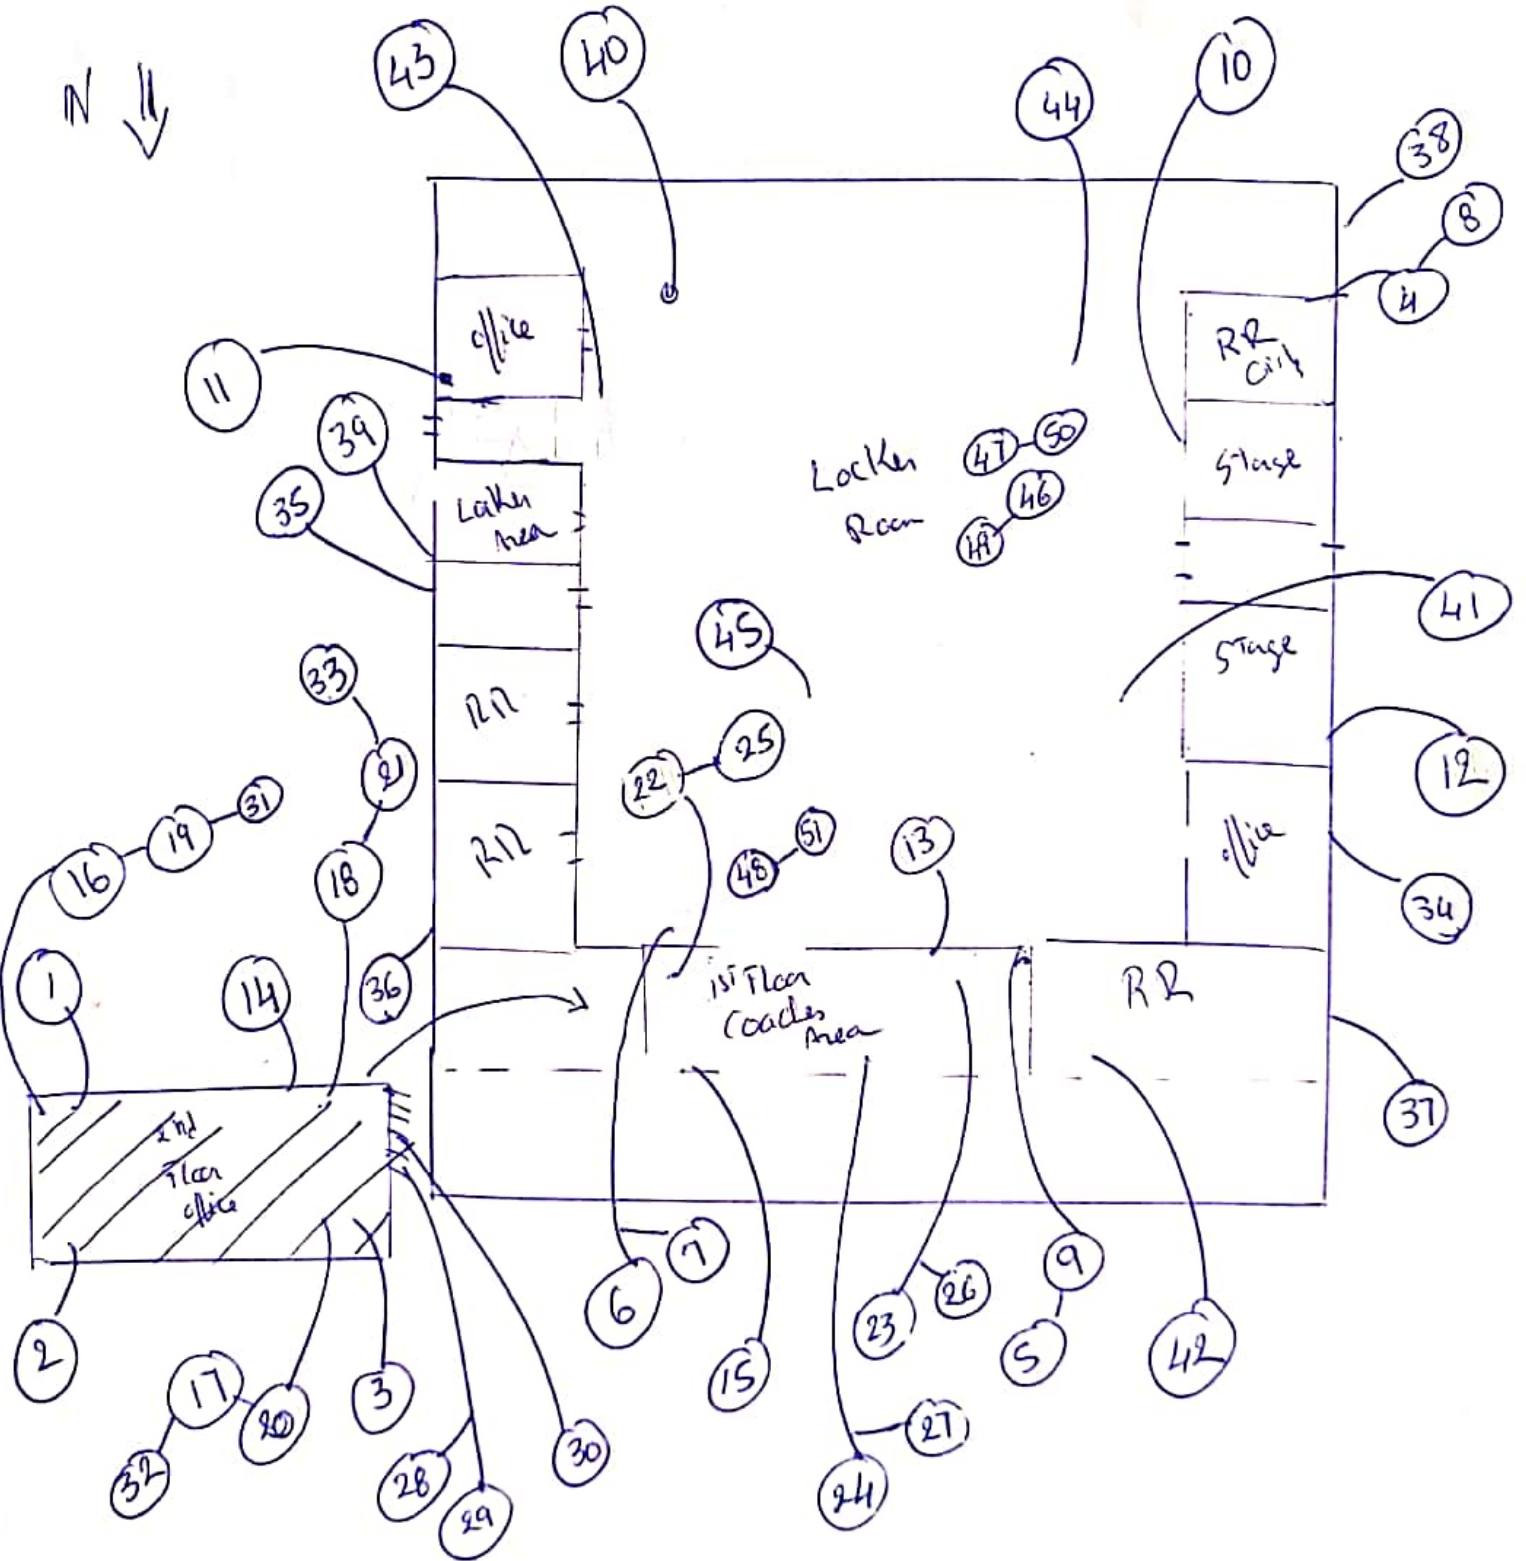
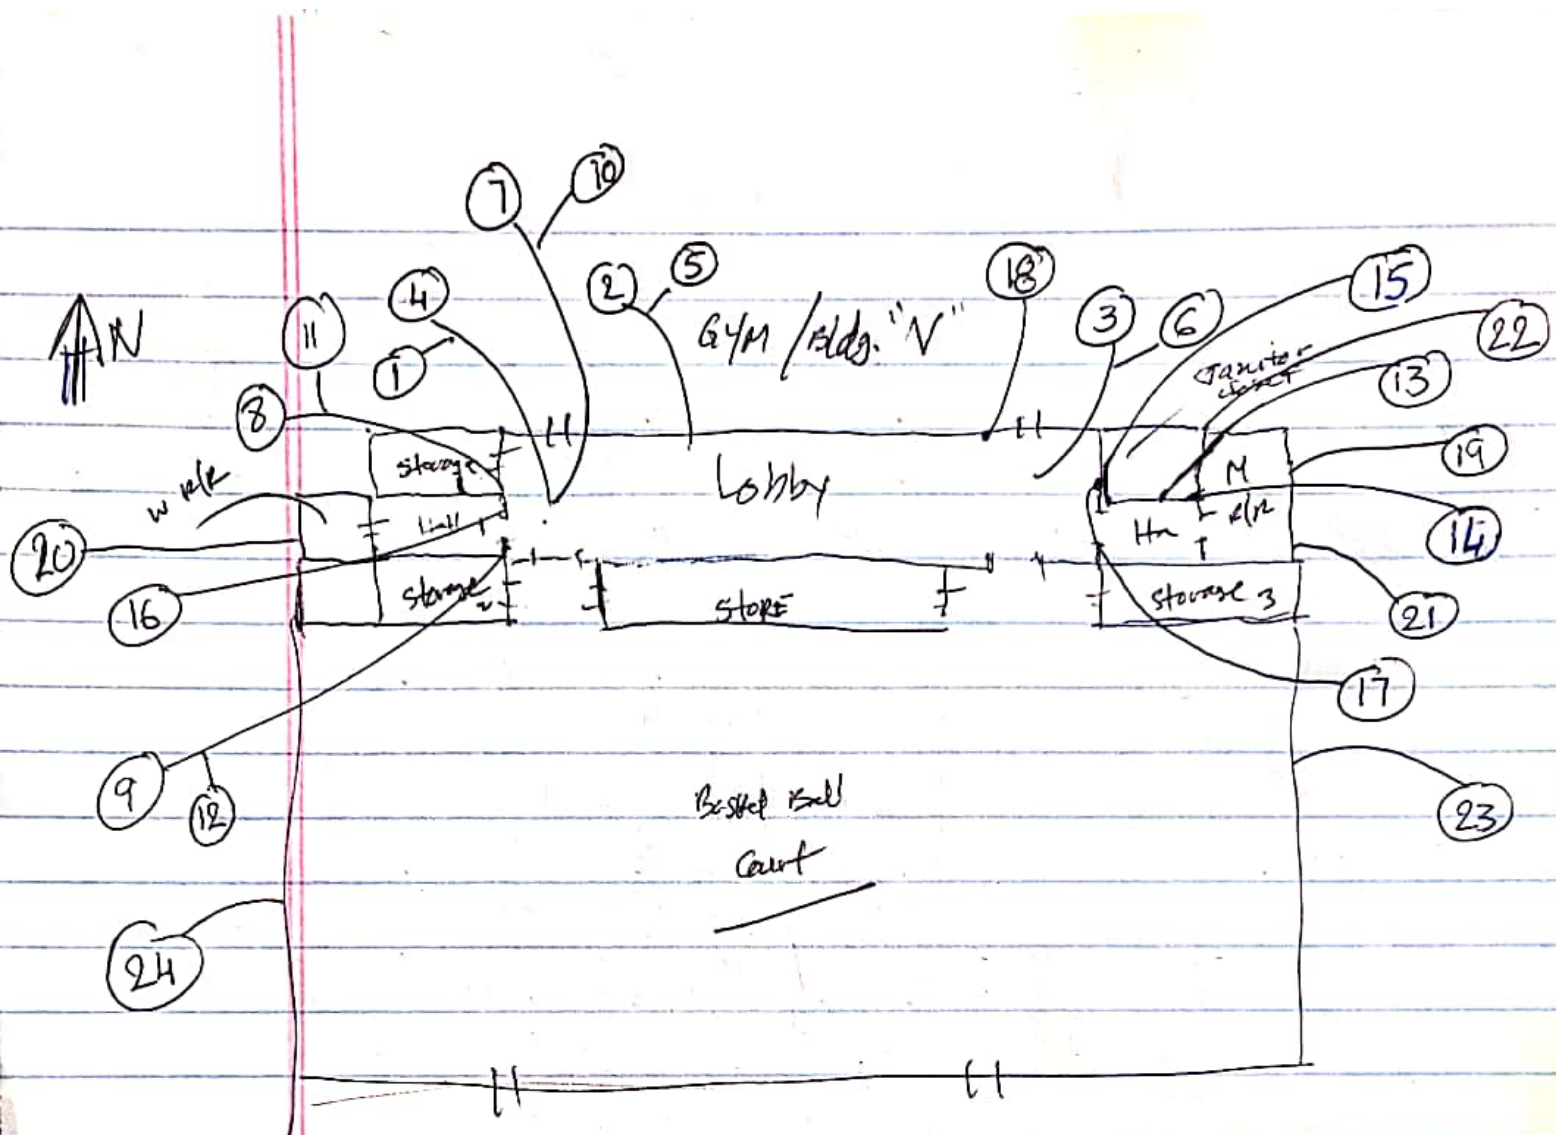
BLDG U

/// 12" Beam RFT
& Mastic
