**Asbestos Survey for  
Rio Mesa High School  
545 Central Ave  
Oxnard, California 93036**

TC Project No. 103914

Date:  
June 05, 2020

**ASBESTOS SURVEY REPORT**  
**RIO MESA HIGH SCHOOL**  
**OXNARD, CA 93036**  
**OXNARD, CALIFORNIA**

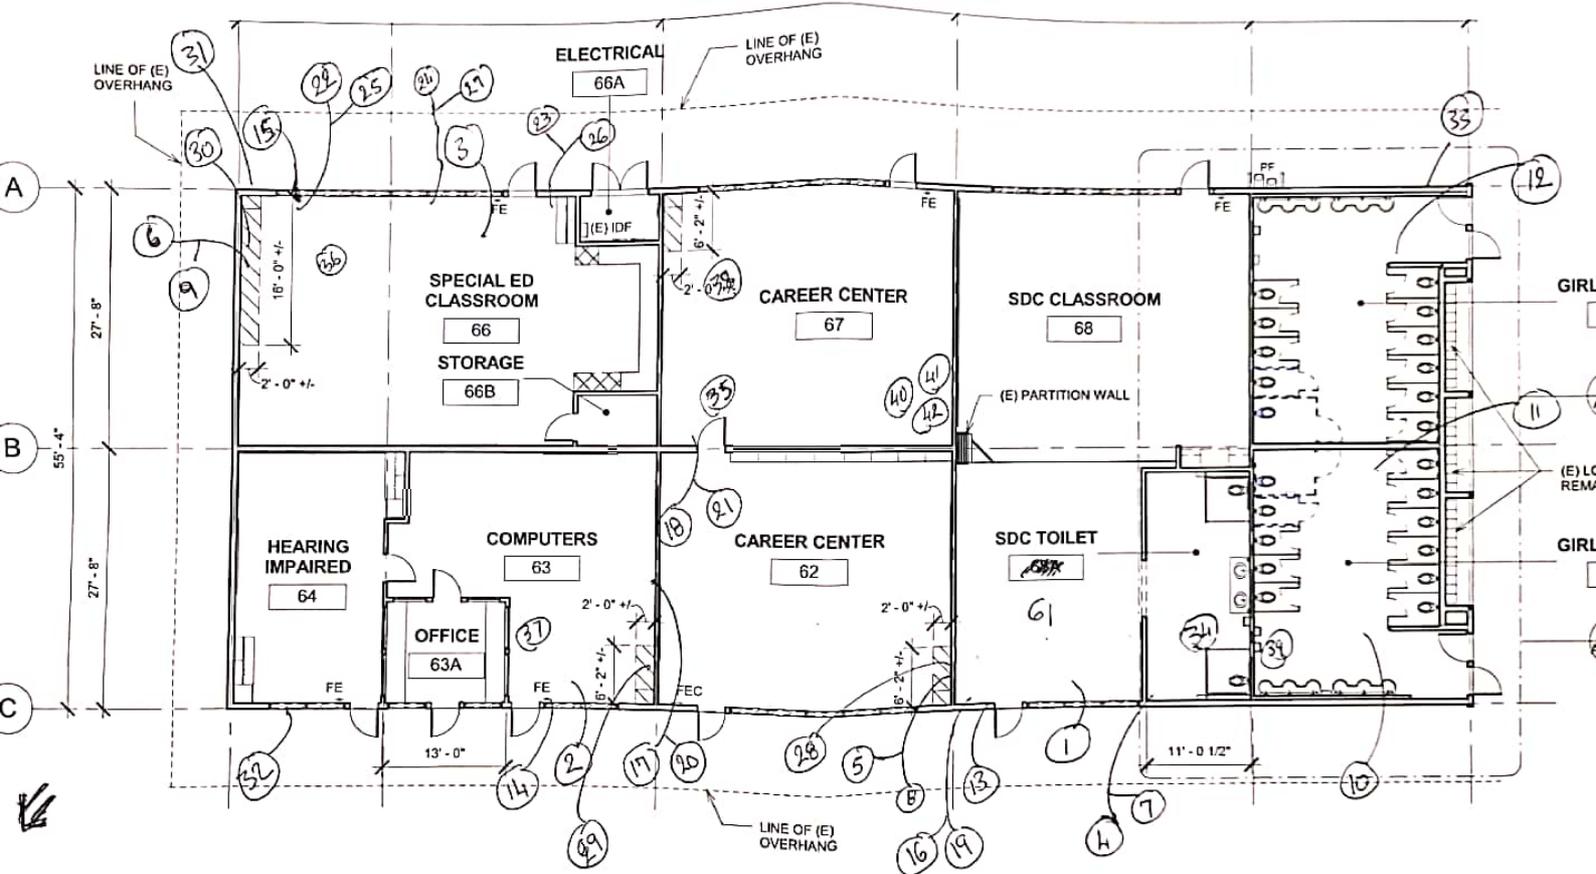
CLASSROOM BUILDING '1' DEMOLITION FLOOR PLAN  
 3/32" = 1'-0"

CM: ---  
 2x4 ACP B *HP*  
 12" ACT *HP*  
 12x12 RFT Beam | under cur = office
